QUALITROL CASE STUDY:

SERVERON™

THE IMPORTANCE OF MEASURING OXYGEN IN DGA

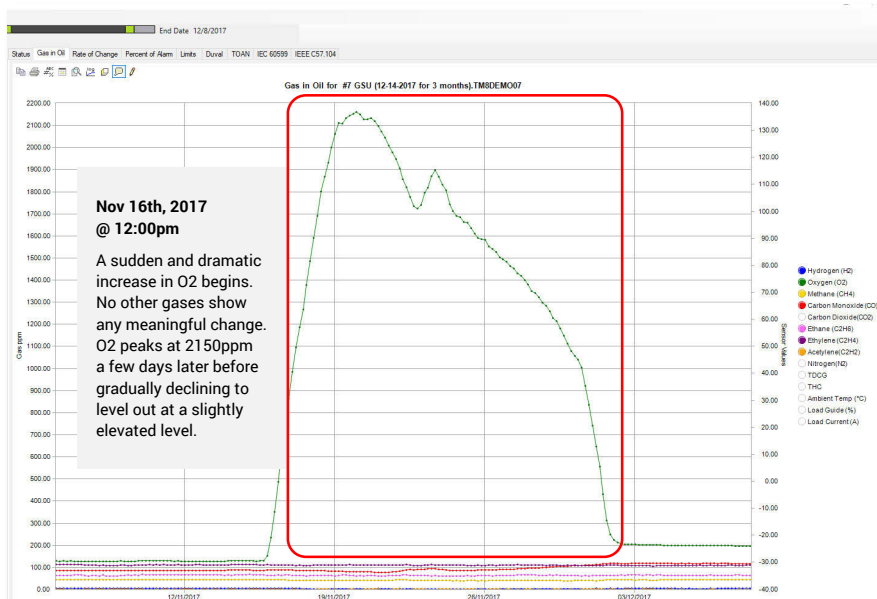
A Qualitrol Serveron TM8 mutli-gas DGA device was monitoring an old (30+ years) 3-phase 230kV shell-form nitrogen (N) blanketed GSU. At midday on November 16, 2017, the TM8 alarmed for increasing concentration of Oxygen (O2), which had been stable at 130ppm for an extended period. Over the course of the following 3 days O2 concentration continued to increase, peaking at 2,150ppm before gradually declining back to a stable 200ppm.

Reviewing the data around the time of the increase in O2 concentrations using Serveron TM View software, no fault is detected using any of the established diagnostic methods.
