QUALITROL CASE STUDY:

SERVERON™

Runaway fault detected by TM8 resulting in action to prevent catastrophic failure.

On August 28th, 2016 a Serveron DGA was being used to monitor a 3-phase, 1100 MVA, 345 kV GSU.

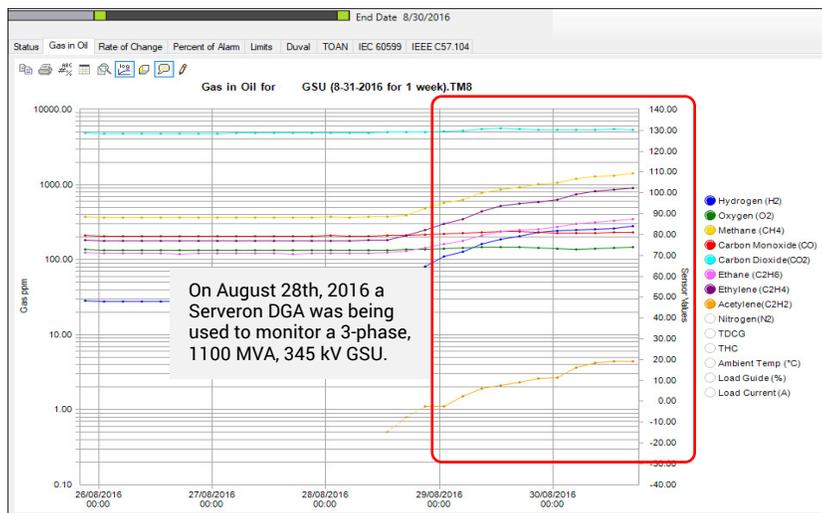
Figure 1: TM View Screen showing the time at which gases started to increase. Log Scale is used to best illustrate the very large increase of gases on a single graph

As a result of its initial problem with the pump, dissolved gas concentration was at a high base level over the following 21+ months; Gas concentrations were high but stable. In the afternoon of 28th, gas concentration started to climb. By midnight there was a steady increase in the concentration of all gases. While the gas concentration increase was significant it was not enough to trigger the buchholz relay and so the transformer was allowed to continue to operate. Load was reduced on the transformer with no change in gassing rates as measured by the Serveron online DGA monitor. The transformer was taken offline on August 30th to perform an internal inspection and repairs if possible.

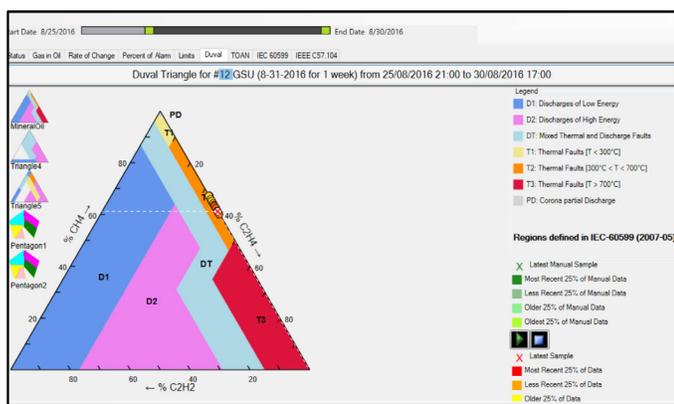
All diagnosis systems (Table 1) pointed to a thermal fault >300°C with some suggestion that there was paper involved. While the ratios of gases before this gas generation event occurred would have indicated the same diagnosis (See Figure 1 & Figure 2 where the diagnosis remains in the same location) it was the rapid change in gas concentration, as alarmed by the Rate of Change alarming function in TM8 that drove the utility to take action, resulting in the eventual full shedding of load for inspection.

Figure 1: Duvals TRIANGLE 1. Thermal Fault 300°C – 700°C

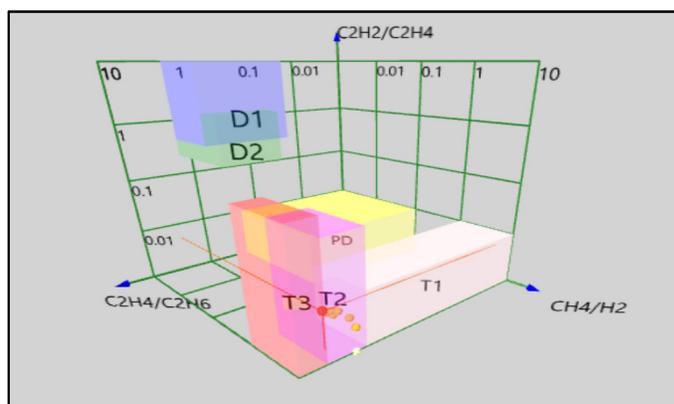
Figure 2: Rodgers Ratio indicating condition T3: Thermal Fault 300°C – 700°C

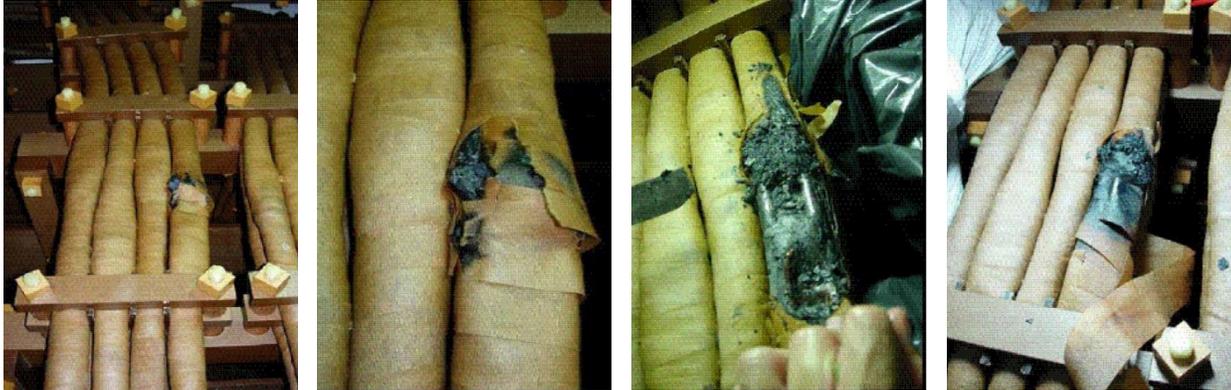
Upon physical inspection it was revealed that localised burning of paper had occurred. The inspection revealed a severely damaged crimped connection between LV cables connecting an LV winding-exit to a bushing. The paper wrapping that connection was dark coloured.

Figure 3:
Damaged connection was easily separated when manipulated.

1. The gas generation was found to be due to overheated crimped connections. This was caused by a combination of high eddy losses in the crimps, poor oil circulation in the high-current insulated crimped bundled-areas and to a lesser extent by an uneven current distribution.
 2. The most heavily damaged crimped connection had a degenerative condition initiated by a very high working temperature calculated to be $>300^{\circ}\text{C}$ (consistent with indication per Table 1) which caused a thermal runaway resulting in the sudden gassing increase.
 3. The windings were not impacted
- Remedial work was undertaken, and the transformer was subsequently put back into service.

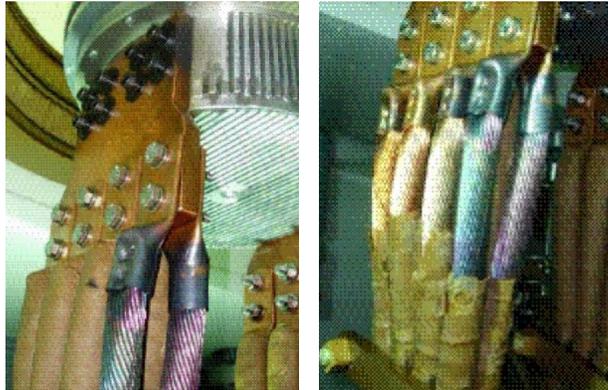
Figure 4: Crimped terminals and cables connected to the bushing's intermediate copper plate.
