AUGUST 2020 • POWER GENERATION

A COMPARATIVE STUDY ON COST SAVINGS OFFERED BY TRAVELING WAVE SYSTEM FAULT LOCATORS OVER TRADITIONAL DISTANCE RELAYS FOR LONG DISTANCE TRANSMISSION LINES

Jonathan M. Trejo – System Protection & Control Engineer, El Paso Electric Company
David Cole – Technical Applications Specialist, Qualitrol

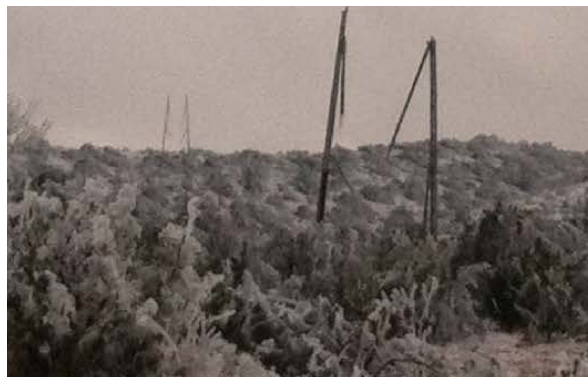
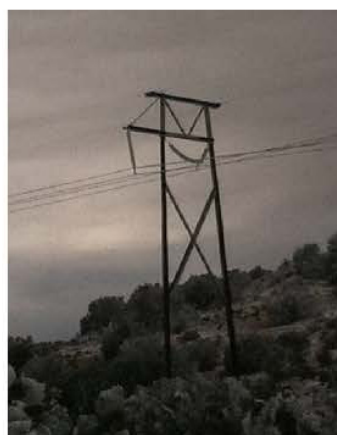
Figure 6 – Broken Structures due to Ice Storm

The 345kV transmission line from Amrad to Eddy County Substations is 125 miles long. A traveling wave distance to fault result after a line trip in 2013 placed the fault 58 miles from Amrad. On arrival the crews found significant damage due to a severe ice storm, 103 structures had collapsed or were damaged over a length of 16.7 miles. See Figure 6. This fault was not hard to find but the speed in obtaining the result and the faith the crews had in the accuracy meant teams were on scene in the minimum time.

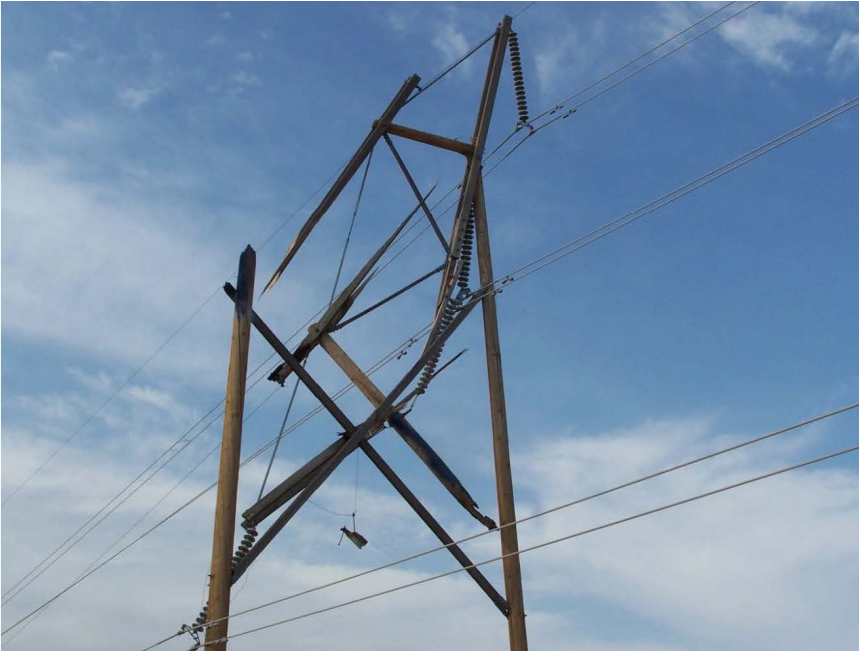
Fig 7 Structure Collapse Due to Fire Damage

The 345kV transmission line from Arroyo to West Mesa Substation was built in 1968 and is 201 miles long. A traveling wave distance to fault result after a line trip in April 2016 placed the fault 53 miles from Arroyo. On arrival the crews found significant damage to a structure damaged by fire as shown in Figure 7.

After similar incidents and further examination it was discovered that the fire was caused by the heating of the pole mounted earth wire from induced current due to increased loading on the line. After nearly 50 years in service the weathered poles were drier and more susceptible to burn. The staples used to clamp the earth wire had also worked loose resulting in further arcing. A design alteration to hold the earth wire away from the pole using stand-off supports was implemented on 1500 structures as shown in Figure 8.

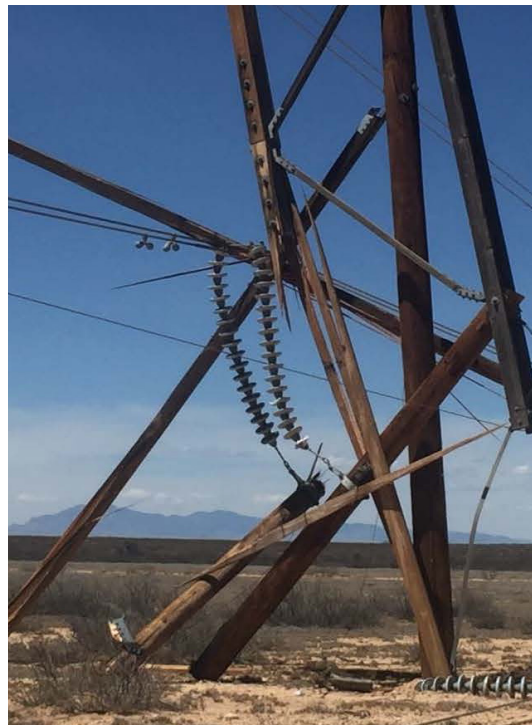
Figure 9 Other Fire Damaged Structures

During the remedial work program the traveling wave system successfully located other fire damaged structures keeping the outage time down to a minimum. See Figure 9. An impedance result from one of these events placed the fault site 30.8 miles from Arroyo substation when the actual distance, as defined by the traveling wave system, was 50.1 miles. Without the traveling wave result it would have taken several days to find the site using a 4 person patrol crew.
