QUALITROL CASE STUDY:

SERVERON™

THE IMPORTANCE OF MEASURING OXYGEN IN DGA

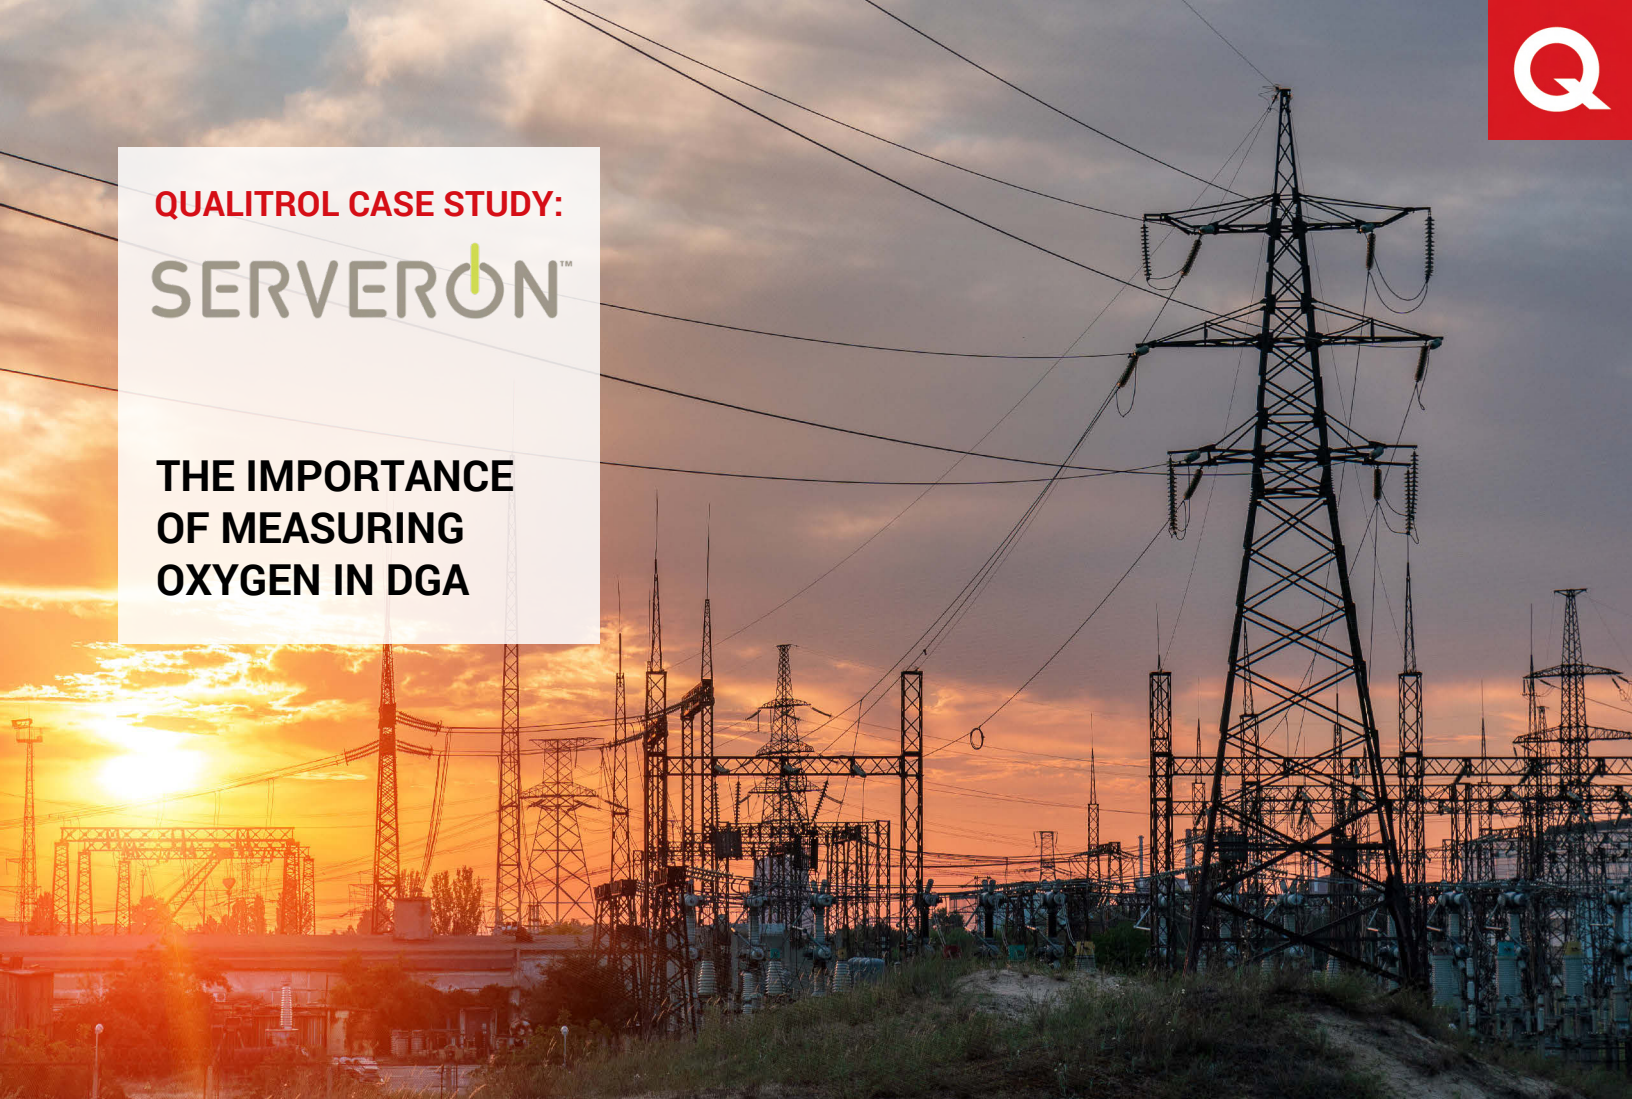
A Qualitrol Serveron TM8 mutli-gas DGA device was monitoring an old (30+ years) 3-phase 230kV shell-form nitrogen (N) blanketed GSU. At midday on November 16, 2017, the TM8 alarmed for increasing concentration of Oxygen (O2), which had been stable at 130ppm for an extended period. Over the course of the following 3 days O2 concentration continued to increase, peaking at 2,150ppm before gradually declining back to a stable 200ppm.

Reviewing the data around the time of the increase in O2 concentrations using Serveron TM View software, no fault is detected using any of the established diagnostic methods.

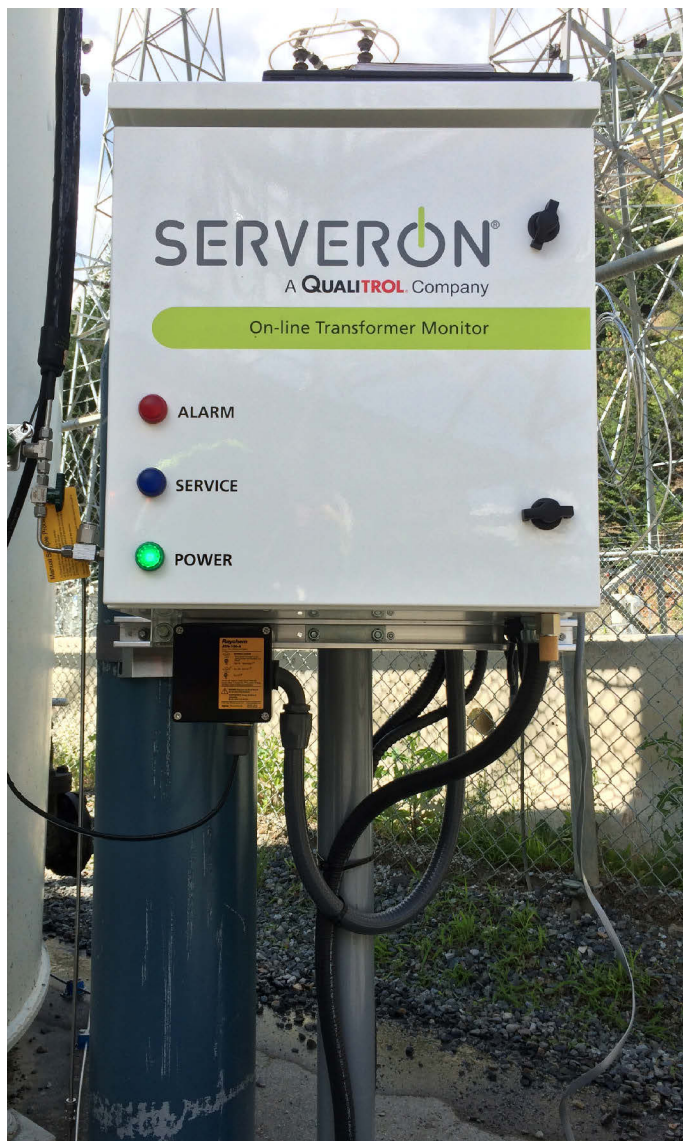
The sudden O₂ increase, with no associated change in any other gas indicated that the O₂ originated from the atmosphere. Qualitrol experts suggested that the transformer may have had an atmospheric air injection and requested the operator to investigate. Upon a physical examination of the transformer it was noticed that there was a leaky manhole cover gasket and that the pressure of the nitrogen blanket was close to atmosphere. It was determined that a partial vacuum occurred in the transformer during a cool down that resulted in atmospheric air being sucked into the transformer.

O₂ can facilitate oxidation in the transformer and thus shorten the life of the paper. However, the big concern with a transformer sucking atmospheric air in is that inevitably, it also brings moisture into the transformer.

"N₂ pressure does not prevent entrance of water--only a good gasket seal does."

While none of the modern diagnosis methods explained this sudden increase in O₂ it was possible to detect this incident with Serveron TM8 online Gas Chromatography Monitor, deduce the cause and implement corrective action. If O₂ was not monitored this process could have occurred many times without being detected, drawing a lot of moisture into the transformer.
